Manhole Inspection Summary

Manhole # S04AA2001MH

Location Address: **3807 LABYRINTH RD**

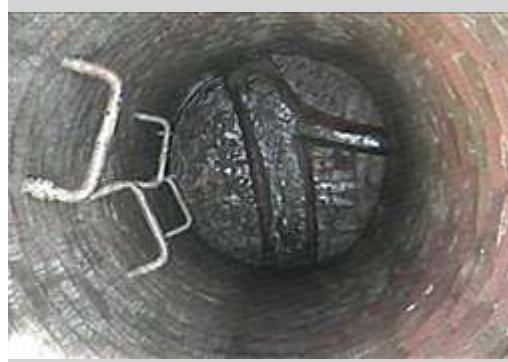
Top View

Adjustment and Barrel infiltration. Bench debris.

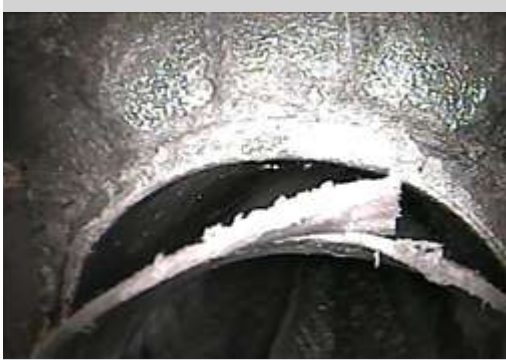
Defect

Liner seperated from pipe

Comments **The I6 pipe liner needs to be replaced.**

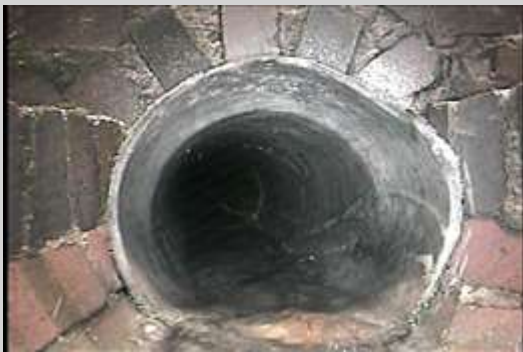
10 in. Circular Gravity Sewer Pipe Out @ 12 O'Clock

Infiltration: **None** Pipe Seal Cond: **Unknown**

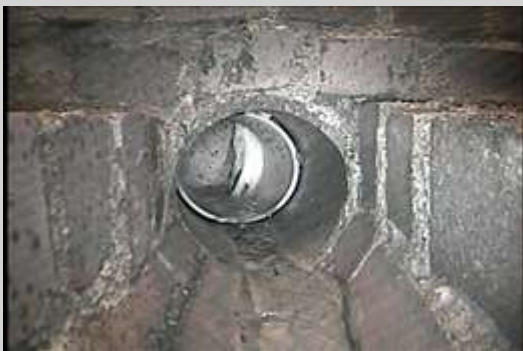
6 in. Circular Gravity Sewer Pipe In @ 3 O'Clock

Infiltration: **Evidence** Pipe Seal Cond: **Unknown**

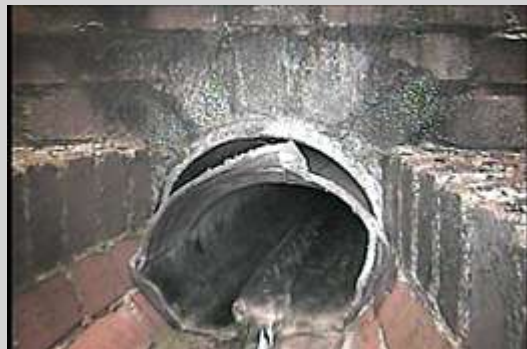
10 in. Circular Gravity Sewer

Infiltration: **None**
